Rosemount Public Library Expansion Feasibility Study

November 06, 2015

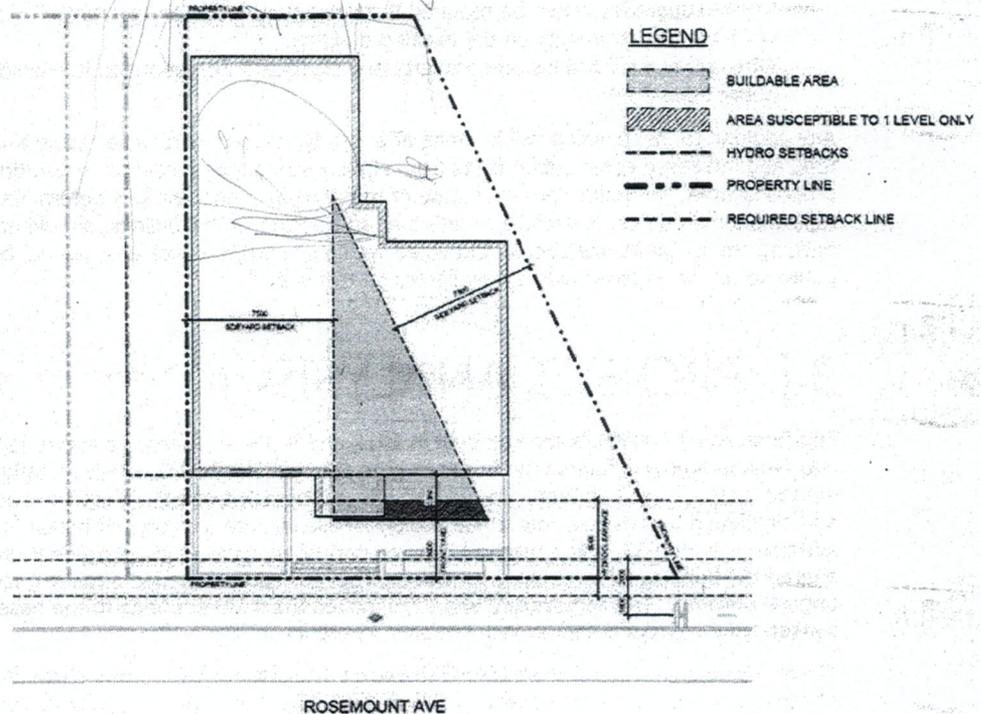
Diagram One – Permitted Buildable Area Allowed with Current Zoning.

Refer to Diagram One for the permitted buildable area based on zoning

The current setbacks that apply to this site result in a small triangular shaped buildable area mostly within the existing building foot print. (See diagram One) A minor variance would be required to add any meaningful additional space to the library. In reviewing this from a conceptual level with City of Ottawa Planners the addition would most likely be recommended and ultimately be approved. However a detailed design would have to be prepared and taken through the minor variance process. Any proposed design presented for a minor variance would have to meet the 4 planning aspects of any minor variance;

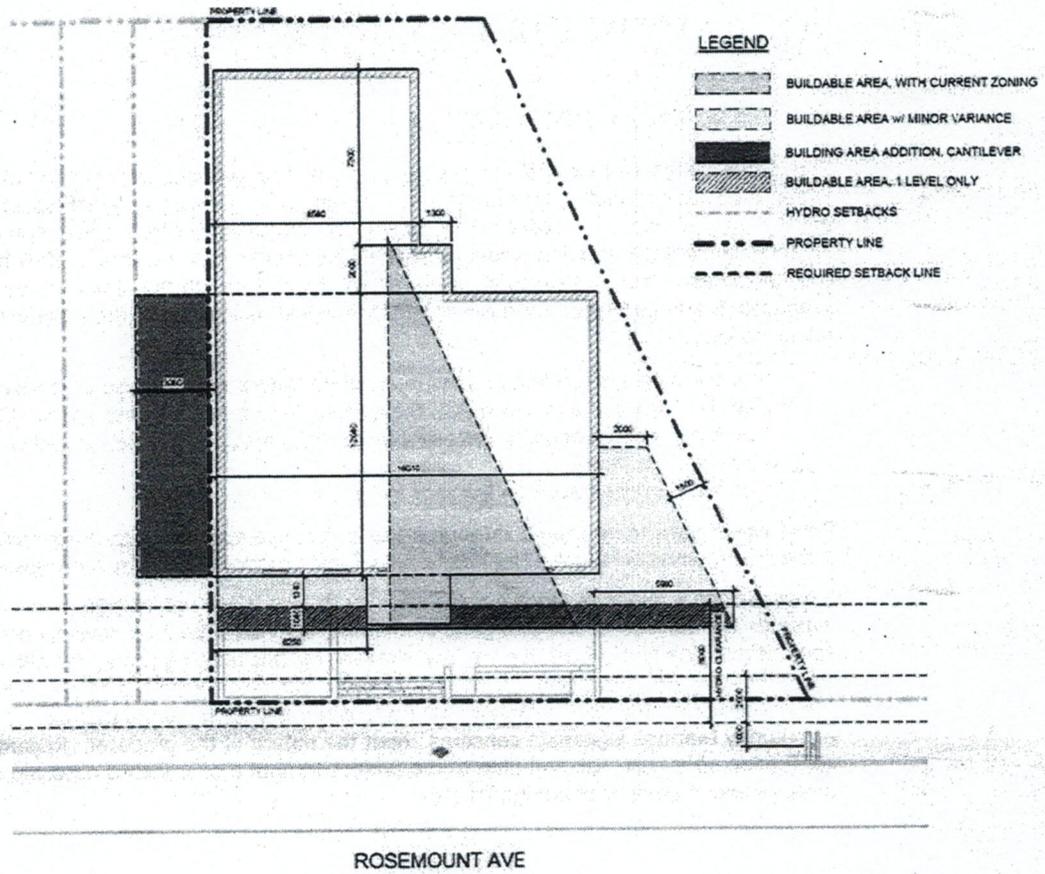
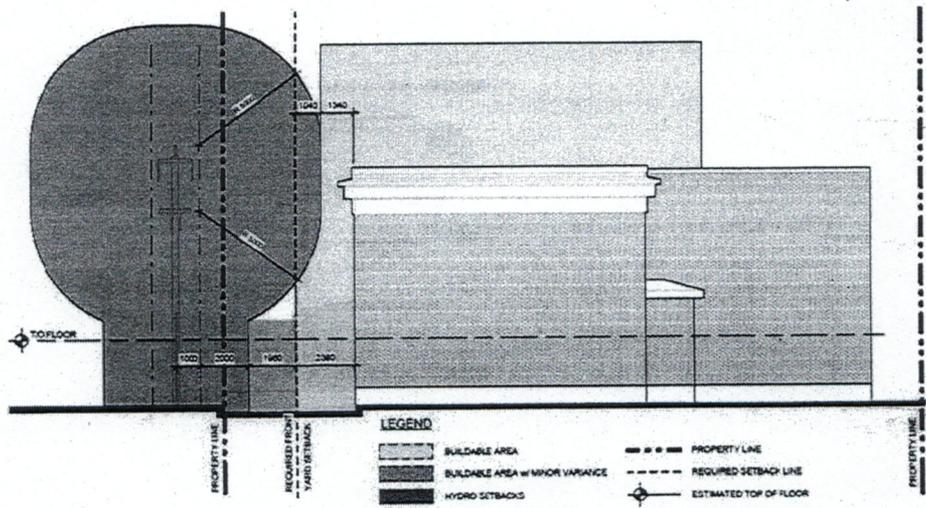
Diagram Two – Potential Buildable Area with Minor Variances.

Relief would have to be sought through a minor variance application for East and West side yard setback and possibly height. The height relief would be determined by a proposed design.

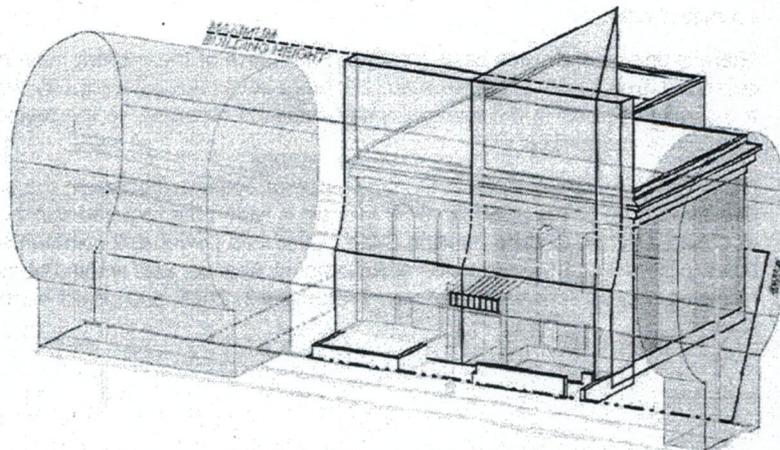
Diagram 3 – Overhead Power line Safety zone with Respect to Building Setbacks

The existing power lines on the west side of Rosemount Avenue limit the extent of any potential addition. A 5m diameter safety clearance is required around the high voltage lines plus a 1m clearance from the pole (below the 5m circular area) that results in a no build zone that impedes on the zoning setbacks and limits any relief through a front back set minor variance. The basement level addition that is the current entrance falls outside this no build zone, however a full main floor addition would be limited to the setbacks outside the red shaded area in image (See diagram 3).

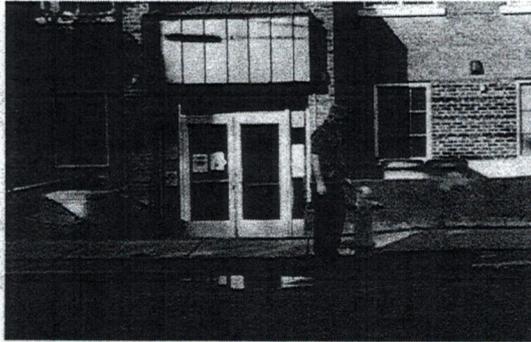
Image 5.3.2.1
View of east face of library building from Rosemount Avenue. City hydrant in foreground. Building water service is buried to the right of the hydrant

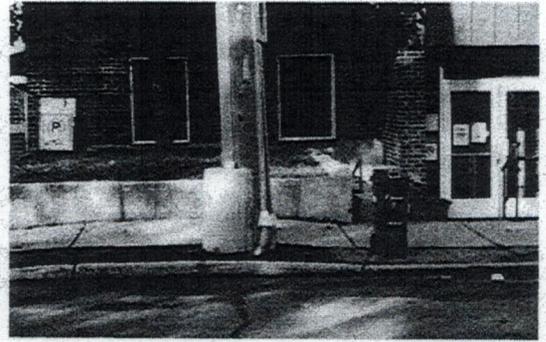
Image 5.3.2.2
Utility pole in boulevard. No services run directly from this pole to the library

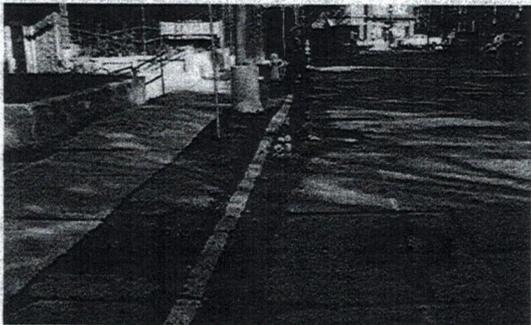
Image 5.3.2.3
View looking north in front of library
Gas line location depicted by yellow paint.

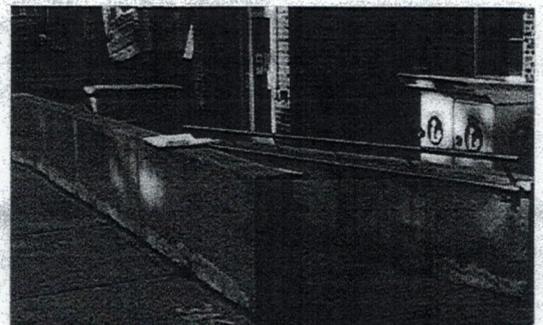
Image 5.3.2.4
Upper end of existing access ramp.

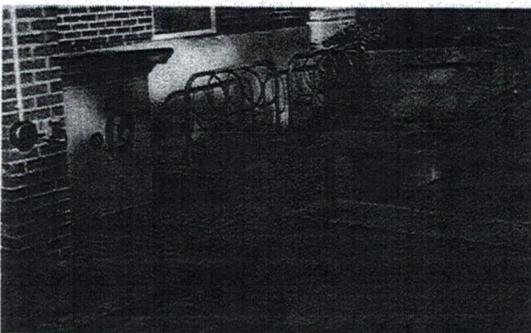
Image 5.3.2.5
Lower east courtyard area, including catch basin near bike rack.

There is one on-site catch basin located to the north of the present main door, in the exterior lowered courtyard area, which is approximately 450mm below the adjacent City sidewalk. No problems related to ponding of water in this lowered area have been reported, so the catch basin appears to be functioning adequately.
